Pike Lake 2011

Review of Findings: Pike Lake

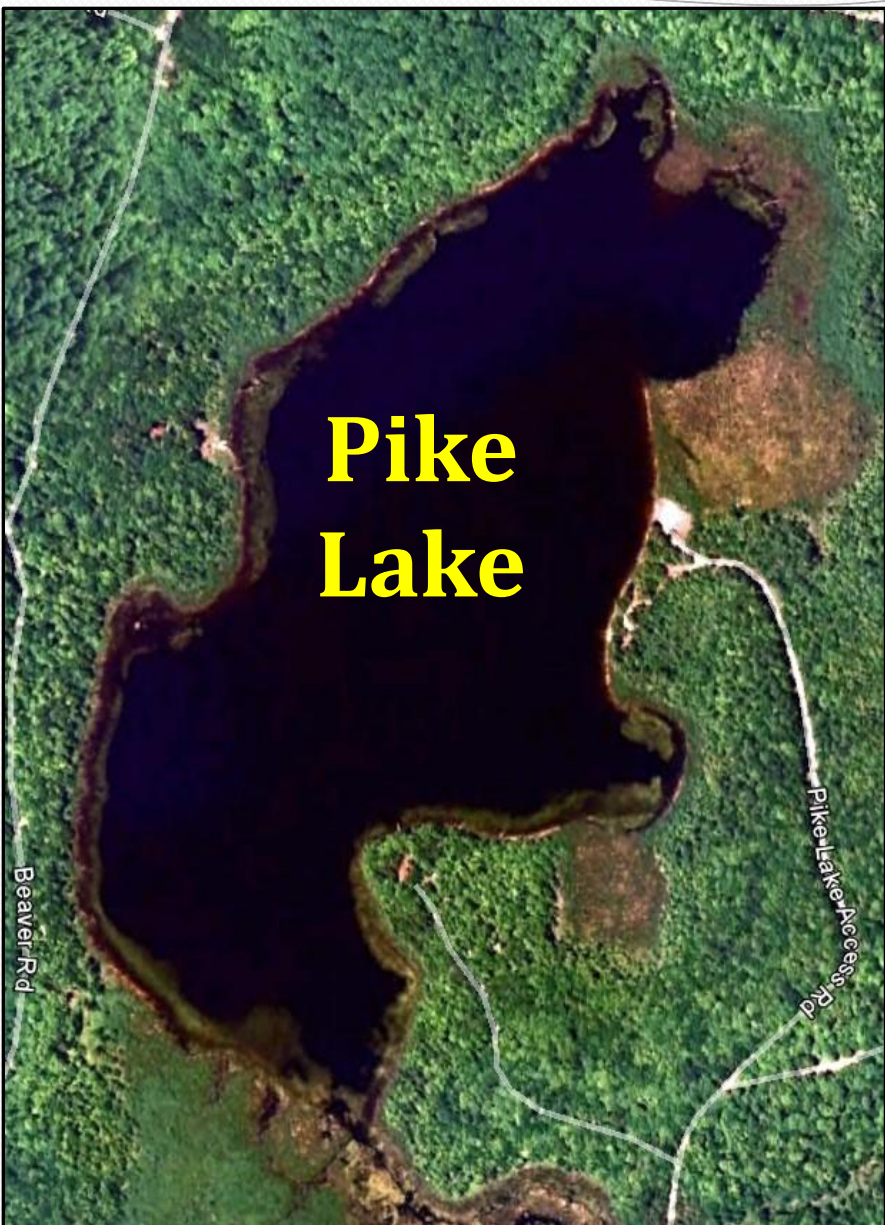
INSTITUTE FOR FISHERIES RESEARCH
 DIVISION OF FISHERIES MICHIGAN CONSERVATION DEPT.
 LAKE INVENTORY MAP
PIKE LAKE
 AREA 83 ACRES
 MARGINAL SURVEY AND SOUNDINGS 8/6/56
 SHORE OUTLINE BASED ON U.S. DEPT. AGRIC. AERIAL PHOTO 10/19/43
 HOUGHTON COUNTY T.51 N. R.36 W. SEC.5, 2, 11

Sampling Point
